News No.25 January 2011

# Soft Tissue Healing Around One Piece Implants: A Two Years Retrospective Clinical Study

Olimpiu L.Karancsi<sup>1</sup>, Radu Sita<sup>1</sup>, Emanuel A. Bratu<sup>1</sup>

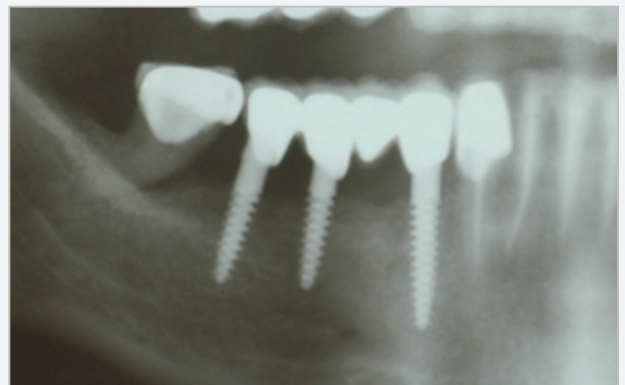
Fig. 3 2 Year postoperative x-ray.

One of the 40 implants failed during the osseointegration phase, probably due to the fact that the bone was extremely narrow at the site. All other 39 implants showed good stability during the 2 years study period. The mean value of bone loss on x-rays was 1,8mm. At the first year, probing depths tended to decrease (as shown on table 1) however, at the 2 year follow-up probing depths were generally higher than after the values found at the end of the first year. This is probably due to bone remodeling around the implant's neck in narrow ridges. In patients with good oral hygiene no bleeding on probing was observed when using the parodontometer Aesculap. There was no significant difference between male and female patients.

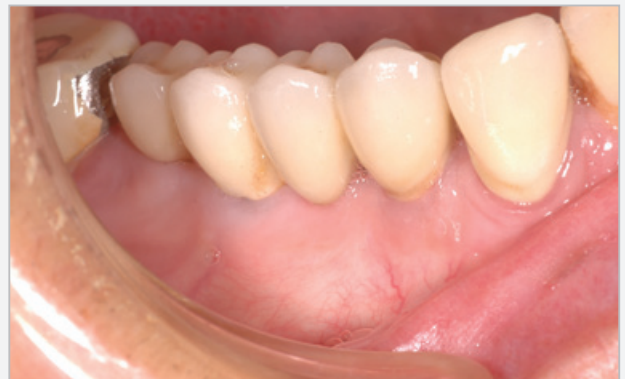
Fig. 4 Final restoration at 2 years.

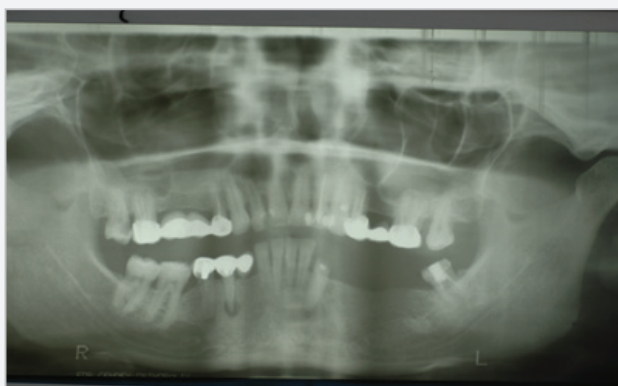
Fig. 5a. Preoperative x-ray. Narrow mandibular ridge.

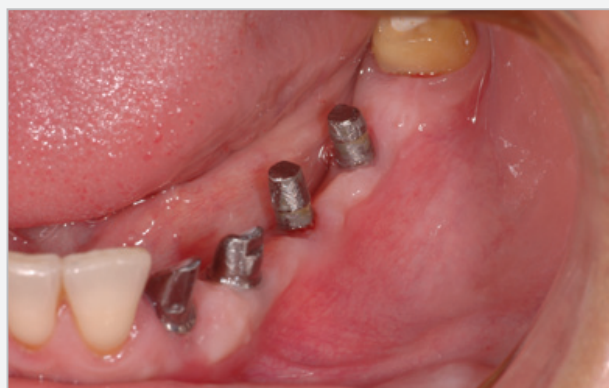
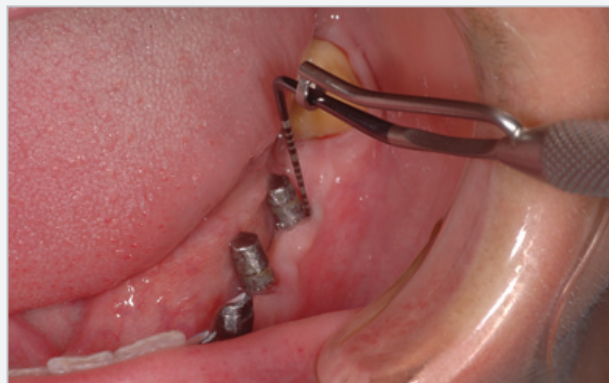
Fig. 6a. Parodontometer AESCULAP measuring device. Note the perfect soft tissue healing after removal of the provisional restoration.

Soft tissue sounding was performed at insertion, at three months after placement, at one year after placement and at two years after placement. Sounding was performed using a parodontometer by Aesculap 0,2 N (20g). Measurements were made on the distal surface of the implant.

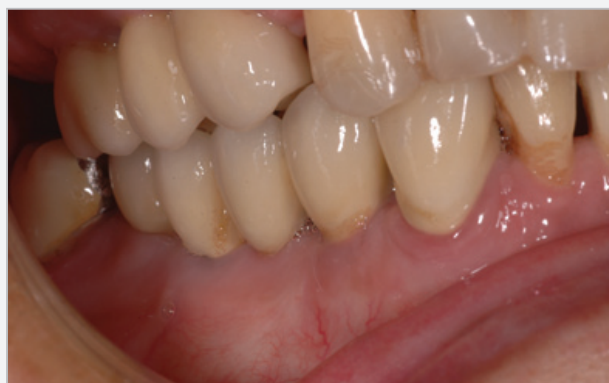
Fig. 7 Final restoration at one year after insertion.

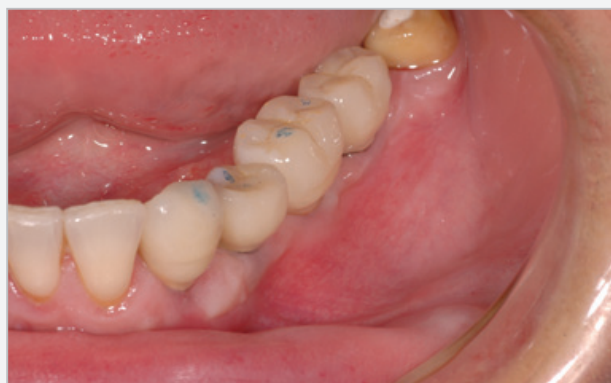
Fig. 10 Occlusion check of the final restoration.

One piece implants with a SLA surface showed very good tissue integration, especially for the soft tissue at the implant neck. This type of implant has even today a large range of uses in almost every clinical situation, presenting a minimal bone loss and allowing insertion in narrow ridges. Large augmentation procedures can be avoided. Even after 2 years of loading no significant modifications of tissue around the implants were visible. Also the prosthetic procedures are simple in case of good positioning of the implants. A problem that can occur in time is that in the case of implant loss and abutment preparation, implant unscrewing can be difficult. This is why sufficient prosthetic space has to be created before implant insertion. Also, the clinician must be aware that only minor changes in implant insertion axis can be obtained with abutment preparation. For that reason, careful preoperative evaluation should be performed and occlusion check should be made after pilot drilling.
